# Douglas S. Santo

May 19, 2026

Subject: Pavement Condition Survey  
Ahwahnee Estates Area  
Opah Drive/Road 621, Lulniu Lane/Wallu Lane Loop Road  
and Associated Cul-De-Sacs  
Madera County, CA

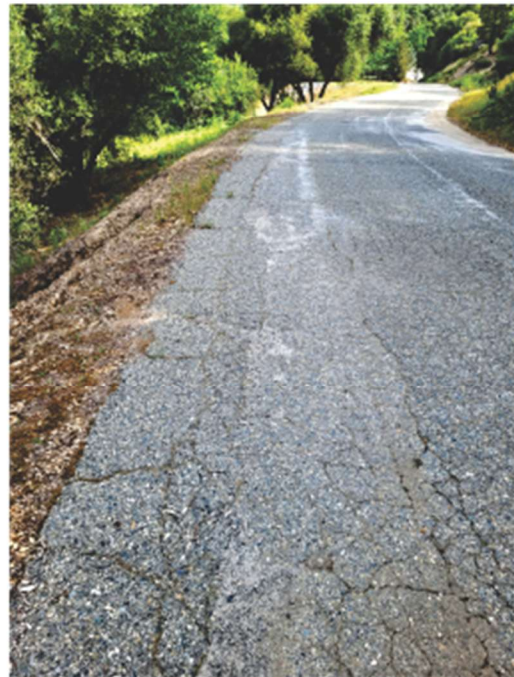
DISTRESS SEVERITY	(Distress severity: L = low M = medium H = high)								TOTAL	DENSITY %	DEDUCT VALUE
	QUANTITY										
1M	19' x 15'	4' x 20'							365	16	57
7M-H	4' x 80'	4' x 80'							640	29	28
10M	90'								90	4	20
19L	23' x 100'								2300	100	16

**PCI RATING  
30  
VERY POOR**

Photo 1 looking north along west edge of road surface showing alligator cracking, edge cracking, centerline longitudinal cracking, and weathering of road surface.

Paved roads observed in this investigation have a Pavement Condition Index between 30 and 12. These roads classify as Very Poor to Serious condition. When combined with age of the pavement, I estimate the asphalt road surfaces are near the end of their useful lives. Pavement rehabilitation or replacement is required.

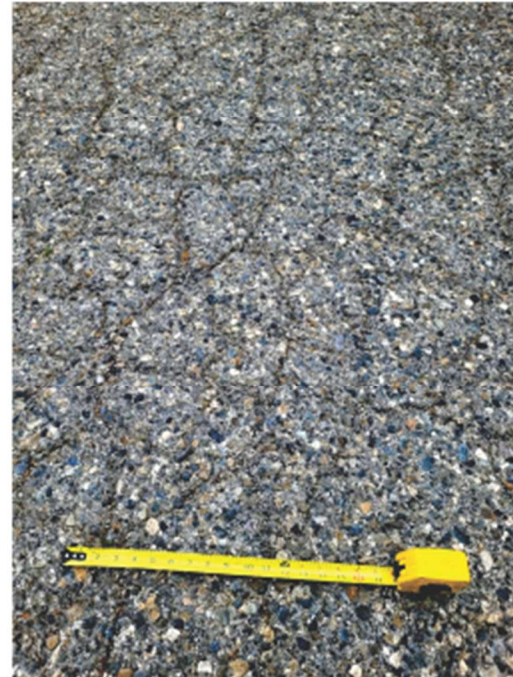
Photo 2, closeup of road surface, showing alligator cracking and weathering. Locally, exposed aggregate is polished but still angular.

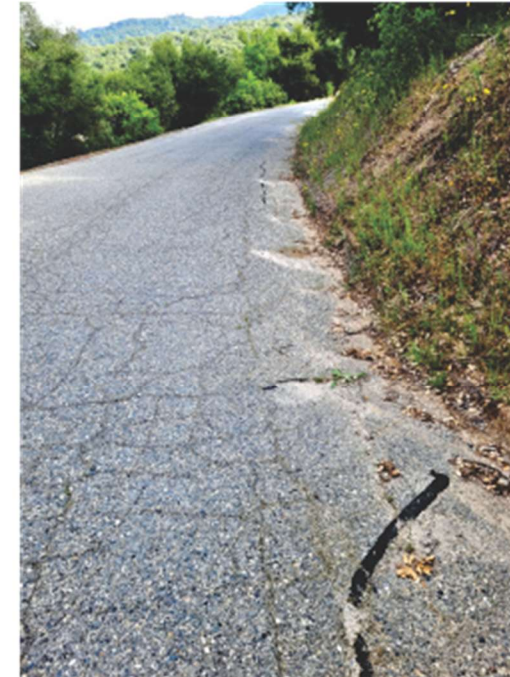
Photo 3 looking north along east edge of road showing previously patched edge cracking and colluvial burial of HMA soil dike.

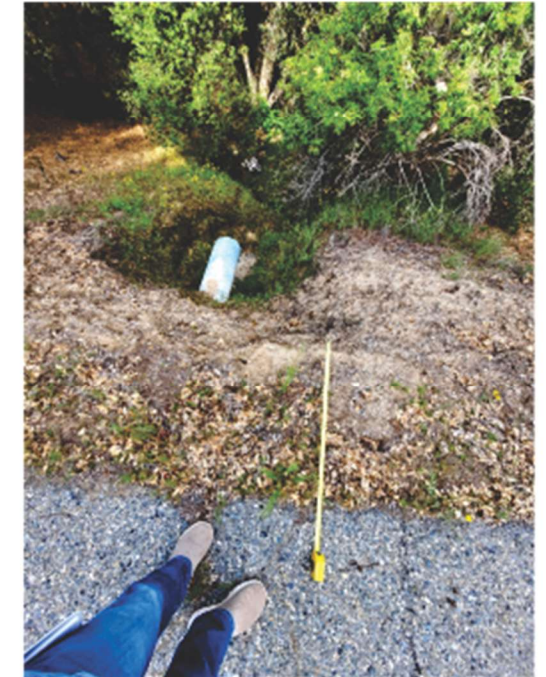
Photo 4 looking west along west edge of road showing erosion, possible piping, and loss of ground of road fill at buried storm drain outlet. Headscarp of the erosion scar approaches to within ~3' of road surface.

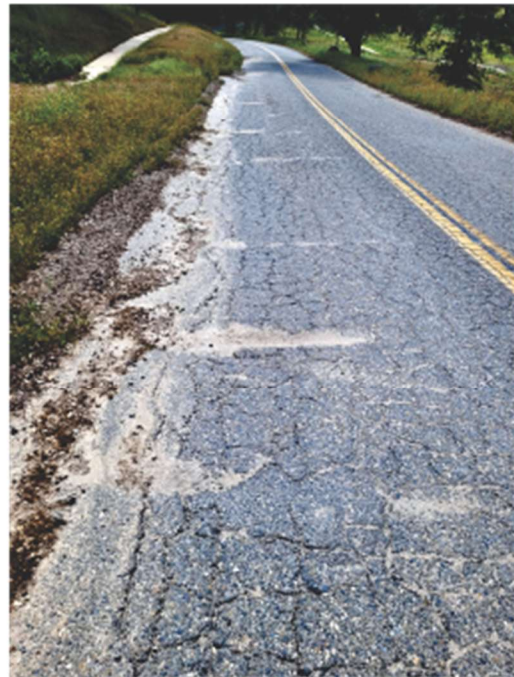
DISTRESS SEVERITY	(Distress severity: L = low M = medium H = high)								TOTAL	DENSITY %	DEDUCT VALUE
	QUANTITY										
1L-H	18' x 90'								1620	70	60
7L-H	4' x 80'								320	14	25
10M	11' 40'								51	2	15
12	4' x 80'								320	14	5
19M-H	23' x 100'								2300	100	44

**PCI RATING  
20  
SERIOUS**

Photo 1 looking east along north edge of road surface showing alligator cracking, edge cracking, longitudinal/transverse cracking, and weathering/ravelling of road surface.

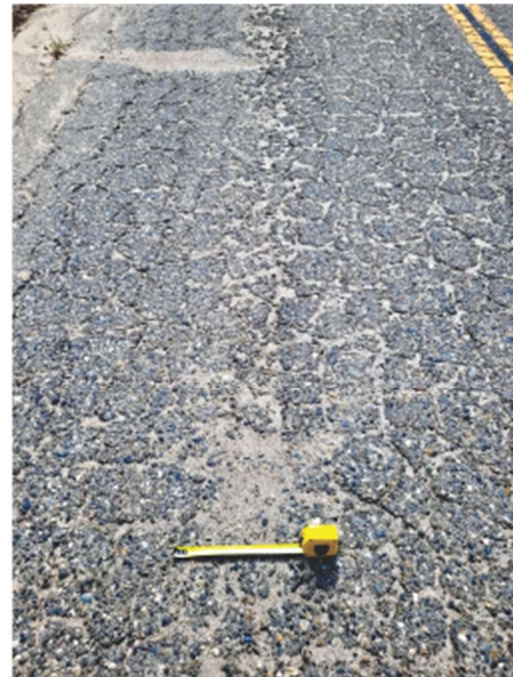
Photo 2, closeup of road surface, showing alligator cracking and weathering/ravelling. Locally, exposed aggregate is polished but still angular.

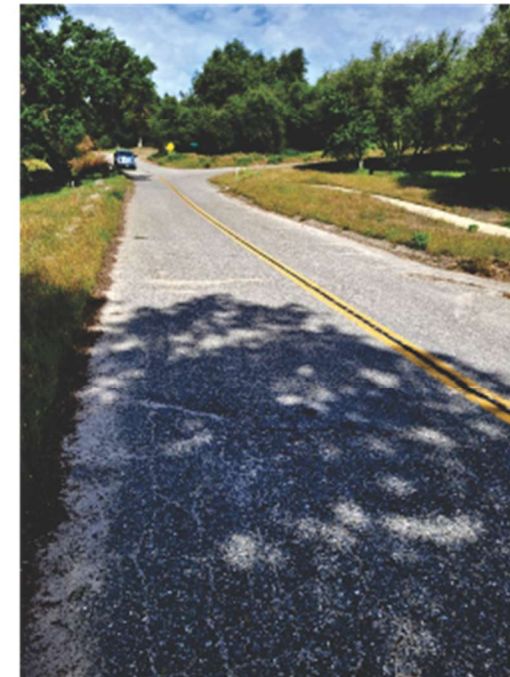
Photo 3 looking west along south edge of road showing edge cracking, transverse cracking, and burial of HMA soil dike.

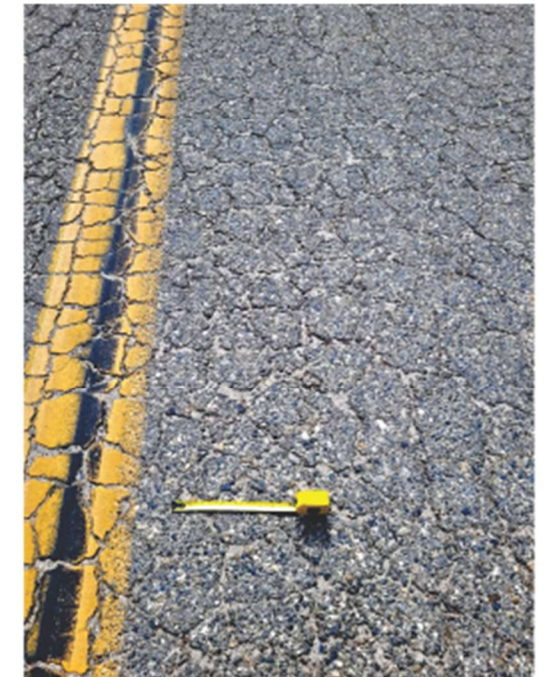
Photo 4, closeup of central road surface showing alligator cracking, and weathering/ravelling. Locally, exposed aggregate is polished but still angular.

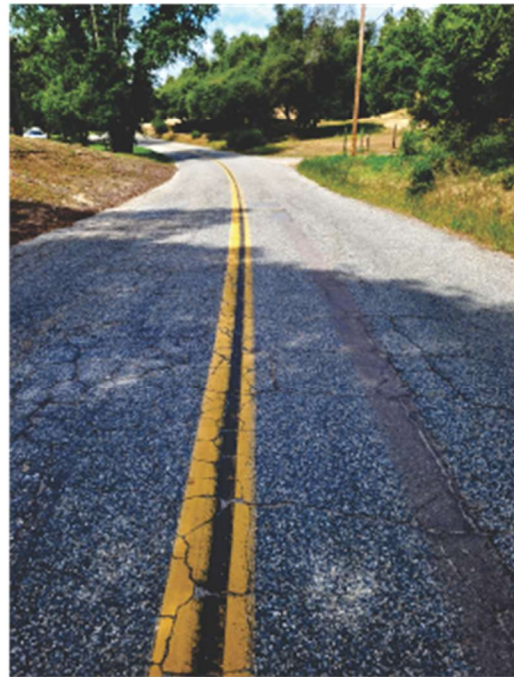
DISTRESS SEVERITY	(Distress severity: L = low M = medium H = high)						TOTAL	DENSITY %	DEDUCT VALUE
	QUANTITY								
1L-H	8' x 80'	6' x 40'	6' x 40'				1120	40	65
3L-M	10' x 20'	10' x 10'					300	11	18
6L-M	6' x 50'	4' x 40'					460	16	37
7L-M	4' x 100'	4' x 100'					800	29	28
10M	28'	14'	14'				58	2	15
12	4' x 100'	6' x 50'					700	25	7
19L-M	28' x 100'						2800	100	43

**PCI RATING  
12  
SERIOUS**

Photo 1 looking southwest showing alligator cracking, block cracking, depressions, and weathering of road surface.

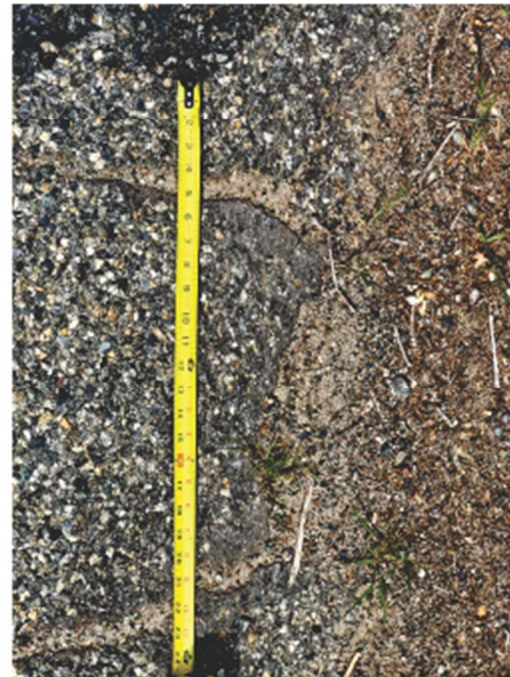
Photo 2, closeup of road surface, showing edge cracking and weathering.

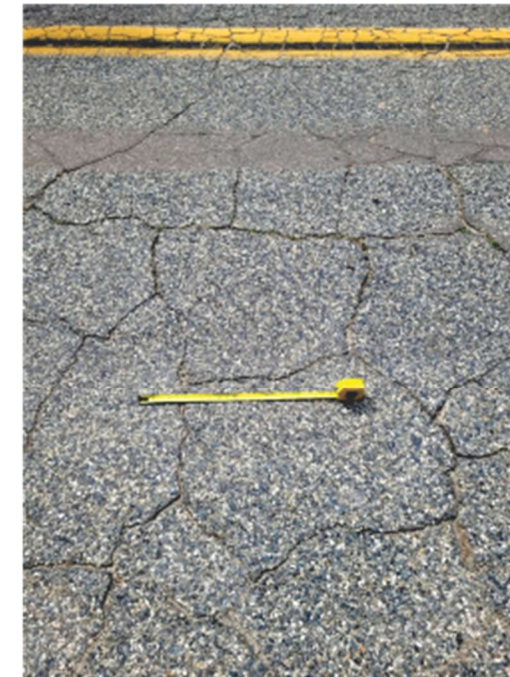
Photo 3 closeup of road surface showing block cracking, alligator cracking, depression, and weathering.

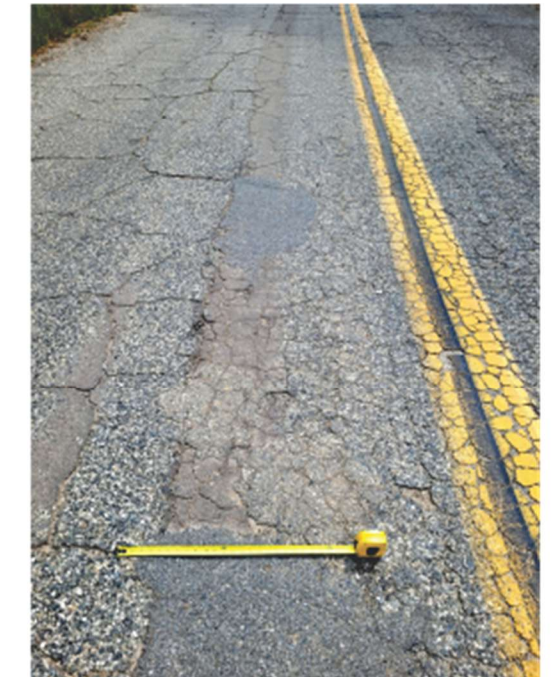
Photo 4, closeup of central road surface showing alligator cracking, block cracking, depression, and weathering/raveling. Locally, exposed aggregate is polished but still angular.

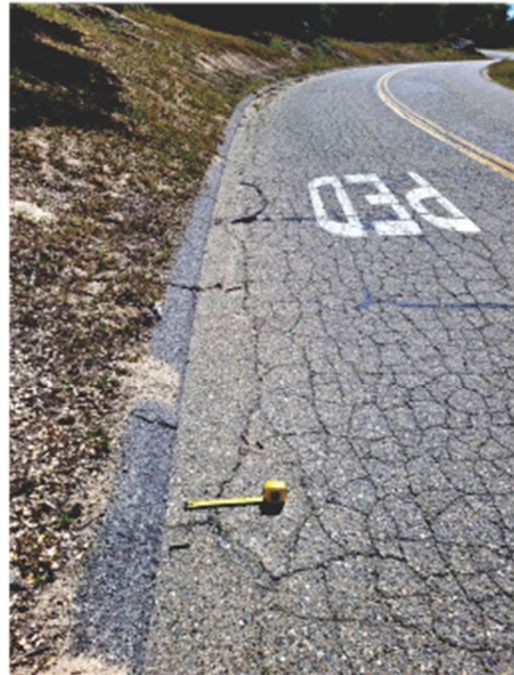
DISTRESS SEVERITY	(Distress severity: L = low M = medium H = high)					TOTAL	DENSITY %	DEDUCT VALUE
	QUANTITY							
1L-M	11' x 80'					880	38	64
3L-M	8' x 15'	6' x 20'				240	10	17
7L-M	3' x 60'					180	8	22
10M	23'	11'	8'	6'		48	2	15
11M	1.5' x 2'					3	0.1	3
12	8' x 20'	4' x 30'				280	12	4
19L-M	23' x 100'					2300	100	43

**PCI RATING**  
**16**  
**SERIOUS**

Photo 1 along northeast side of road looking southeast showing edge cracking, alligator cracking, transverse cracking, cracking in HMA soil dike, and weathering of road surface.

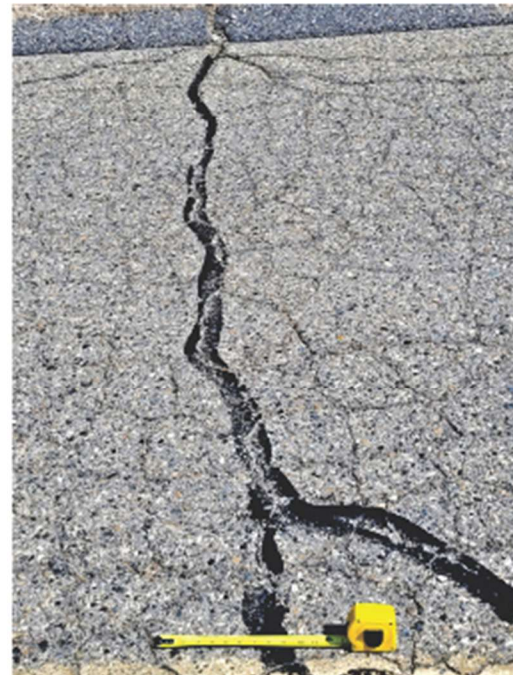
Photo 2, closeup of road surface, showing patched and reopened transverse cracking, alligator cracking, edge cracking, weathering, and locally polished aggregate.

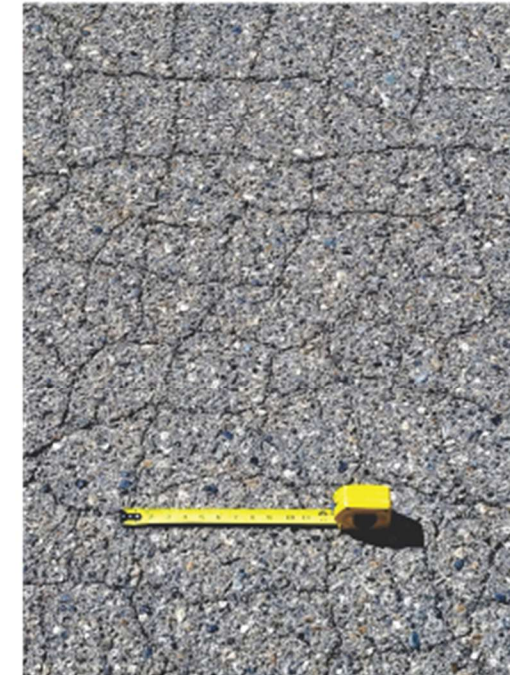
Photo 3 closeup of road surface showing alligator cracking, polished aggregate, and weathering.

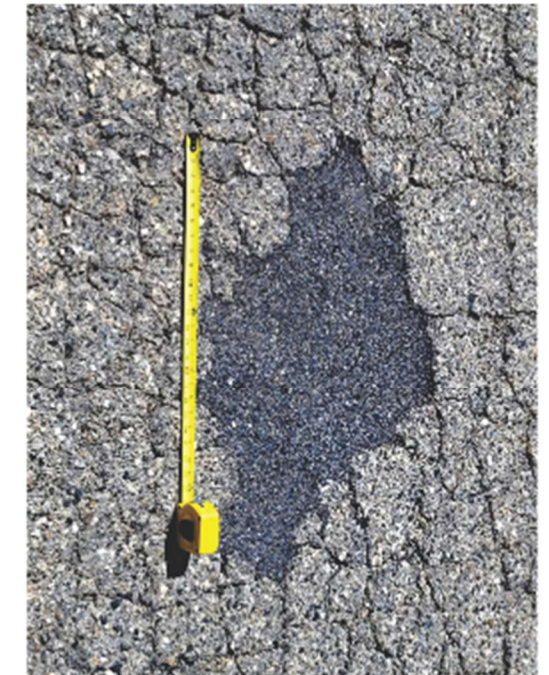
Photo 4, closeup of road surface showing alligator cracking, patched pothole, and weathering/raveling.

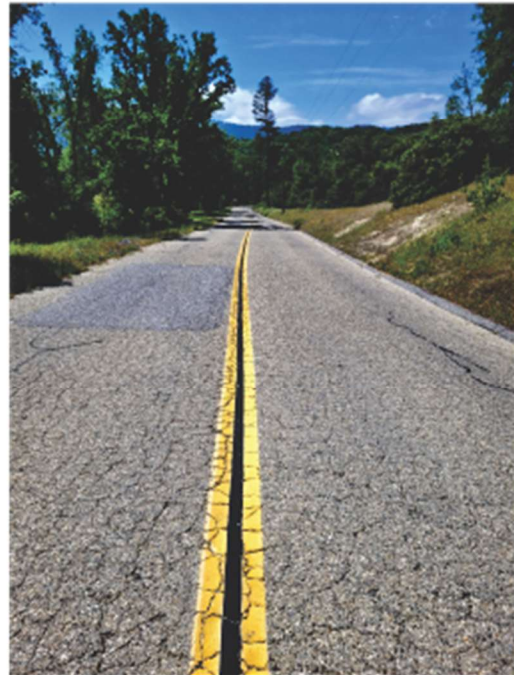
DISTRESS SEVERITY	(Distress severity: L = low M = medium H = high)					TOTAL	DENSITY %	DEDUCT VALUE
	QUANTITY							
1L-M	8' x 100'					800	32	62
6L-M	3' x 12'					36	1.4	10
10M	8'	10'	16'	12'	13'	59	2.4	7
11L	10' x 30'	1.5' x 3'	2.5' x 6'			320	13	19
12	4' x 15'	4' x 20'				140	6	2
19L-M	25' x 100'					2500	100	43

**PCI RATING  
22  
SERIOUS**

Photo 1 looking southeast showing alligator cracking, patching, and weathering of road surface.

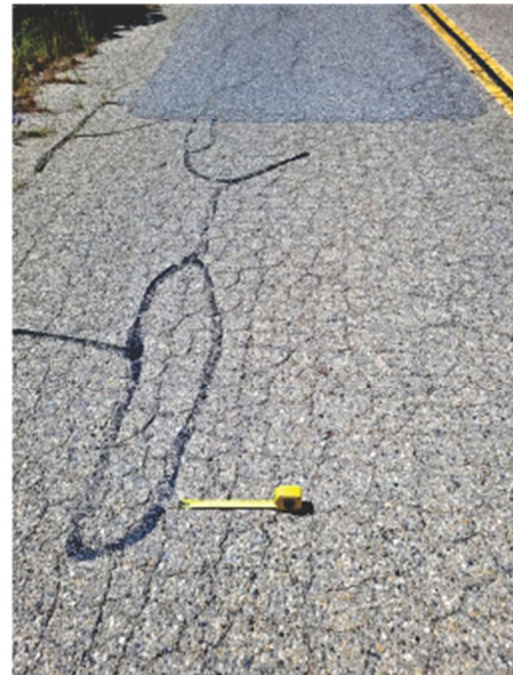
Photo 2, closeup of road surface, showing patched and reopened longitudinal cracking, alligator cracking, weathering, and locally polished aggregate.

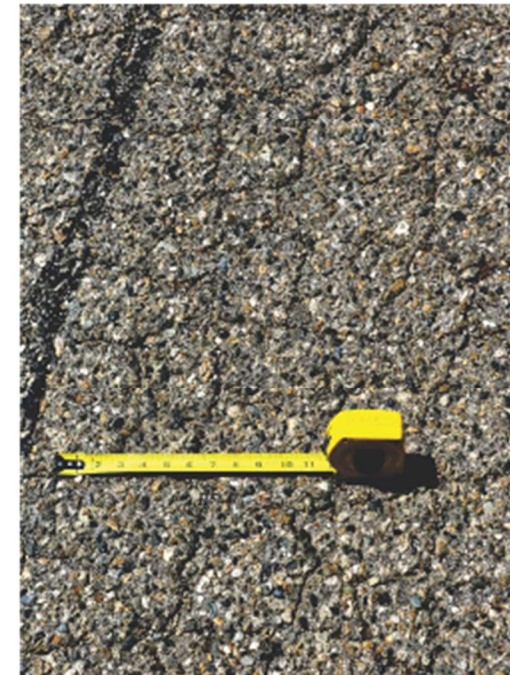
Photo 3 closeup of road surface showing alligator cracking, polished aggregate, and weathering.

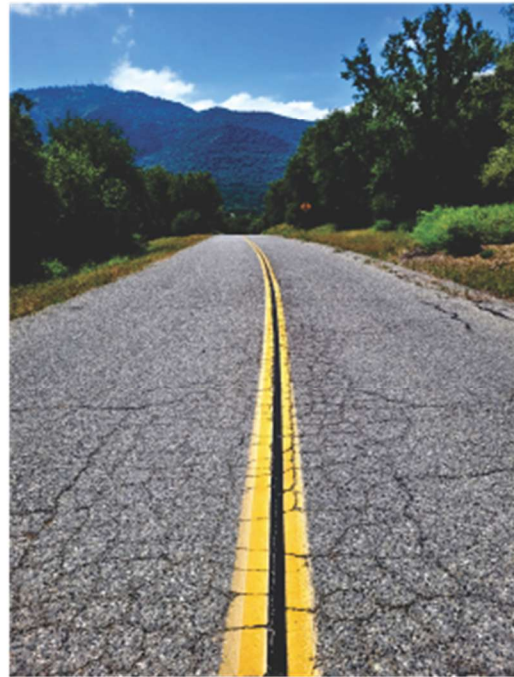
DISTRESS SEVERITY	(Distress severity: L = low M = medium H = high)							TOTAL	DENSITY %	DEDUCT VALUE
	QUANTITY									
1M	6' x 18'	4' x 12'	4' x 12'	6' x 30'				384	14	50
3M	8' x 12'							96	3.4	9
7M	3' x 20'	3' x 80'						300	11	25
10M	14'	8'	14'	14'	28'	28'	28'	134	5	22
19L-M	20' x 80'							1600	57	37

**PCI RATING**  
**25**  
**VERY POOR**

Photo 1 looking south showing alligator cracking, block cracking, longitudinal cracking, and weathering of road surface.

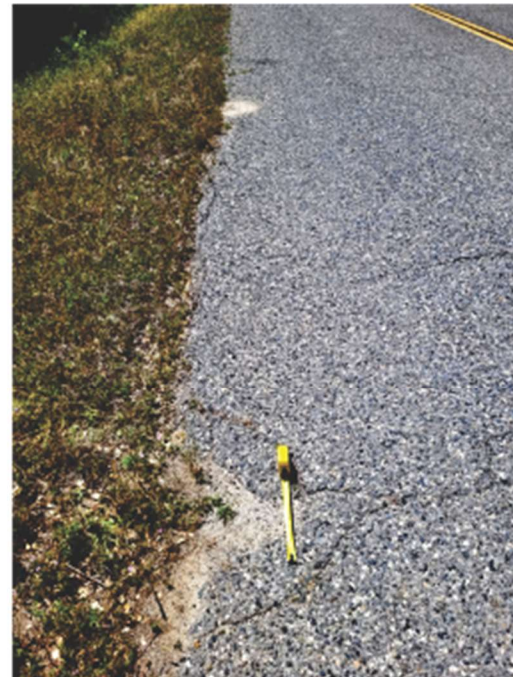
Photo 2, closeup of road surface, showing edge cracking along east side of road, transverse cracking, and weathering.

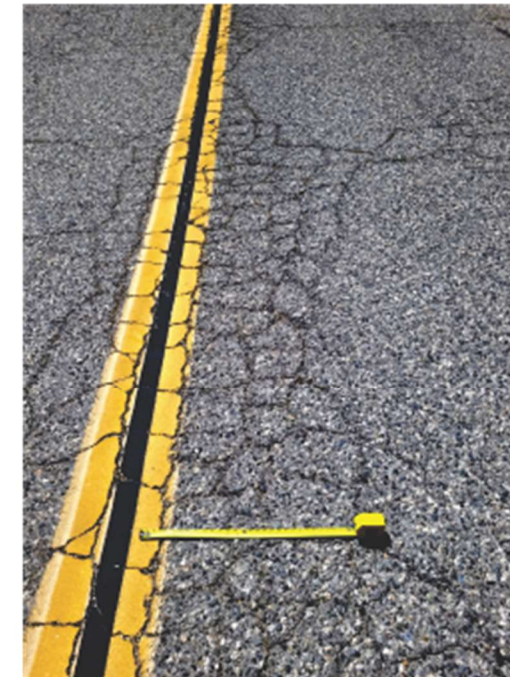
Photo 3 closeup of road surface showing alligator cracking, longitudinal cracking, and weathering.

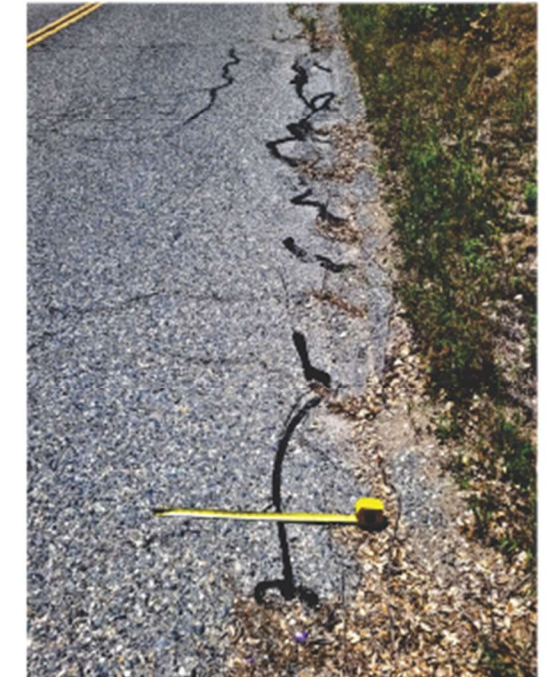
Photo 4 closeup of road surface showing patched edge cracking along west side of road, alligator cracking, longitudinal cracking, and weathering.
