# Douglas S. Santo

May 19, 2026

Subject: Pavement Condition Survey  
Ahwahnee Estates Area  
Opah Drive/Road 621, Lulniu Lane/Wallu Lane Loop Road  
and Associated Cul-De-Sacs  
Madera County, CA

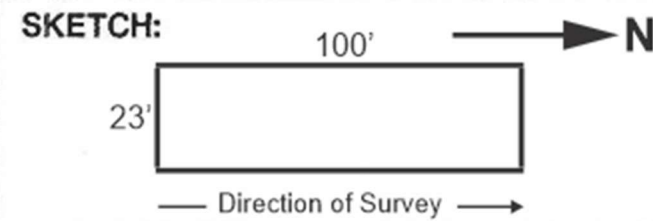
BRANCH Lulniu/Wallu SECTION 1 SAMPLE UNIT 1  
 SURVEYED BY DS DATE 5/3/26 SAMPLE AREA 2,300 sqft

Allowable number of deducts,  $m = 1 + (9/98)(100-57) = 4.9$   
 Pavement Condition Index,  $PCI = 100-70 = 30$   
 See Drawing 1 for location of Branch, Section, and Sample Unit.

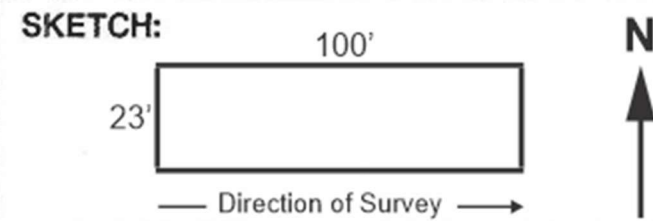
BRANCH Opah SECTION 1 SAMPLE UNIT 2  
 SURVEYED BY DS DATE 5/3/26 SAMPLE AREA 2,300 sqft

Allowable number of deducts,  $m = 1 + (9/98)(100-60) = 4.7$   
 Pavement Condition Index, PCI, = 100-80 = 20  
 See Drawing 1 for location of Branch, Section, and Sample Unit.

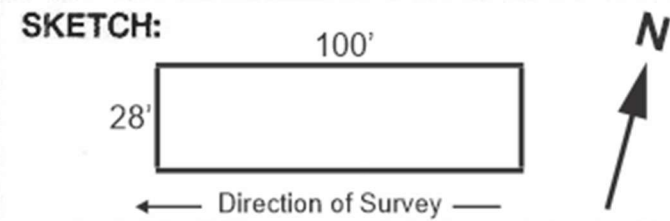
BRANCH 621 SECTION Paved SAMPLE UNIT 4  
 SURVEYED BY DS DATE 5/3/26 SAMPLE AREA 2,800 sqft

Pavement Condition Index, PCI, =  $100-88 = 12$
